# Manhole Inspection Summary

Manhole # **S11QQ\_013MH**

Insp Date: **7/10/09 8:56 AM**

**Location** Address: **3100 CARLISLE AVE**

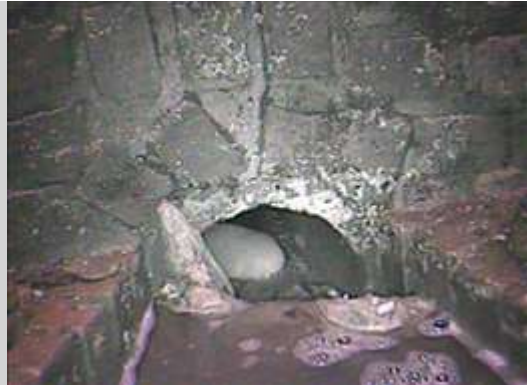
12 O'Clock Outflow

8 in. Circular Gravity Sewer  
Pipe Out @ 12 O'Clock

Pipe Height: (in.) Direct  
Pipe Material: **Clay** ☐ Pipe Lined  
Invert Depth: **17.50** (ft.) Flow Characteristics: **Slow**  
Deposits: ☐ None ☐ Mud ☐ Sludge ☒ **Debris** ☐ Grease  
Silt Depth: **4** (in.) Deposits Extent: **Medium**  
Infiltration: **None** Pipe Seal Cond: **Broken**

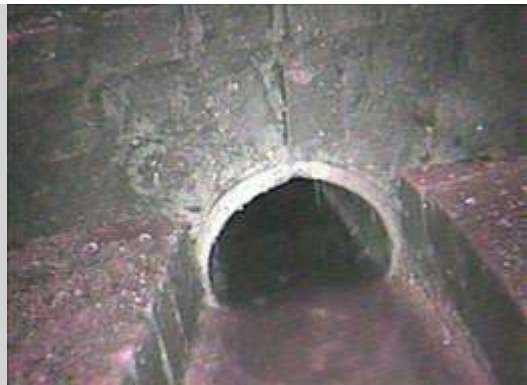
4 O'Clock Inflow

8 in. Circular Gravity Sewer  
Pipe In @ 4 O'Clock

Pipe Height: (in.) Direct  
Pipe Material: **Clay** ☐ Pipe Lined  
Invert Depth: **17.49** (ft.) Flow Characteristics: **Slow**  
Deposits: ☒ **None** ☐ Mud ☐ Sludge ☐ Debris ☐ Grease  
Silt Depth: (in.) Deposits Extent:  
Infiltration: **None** Pipe Seal Cond: **Cracked**

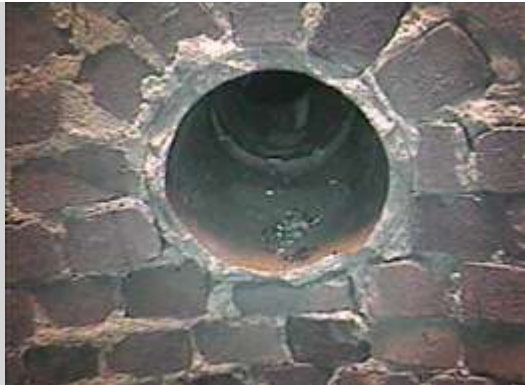
6 O'Clock Inflow

Pipe In @ 6 O'Clock

Infiltration: **None** Pipe Seal Cond: **Sound**

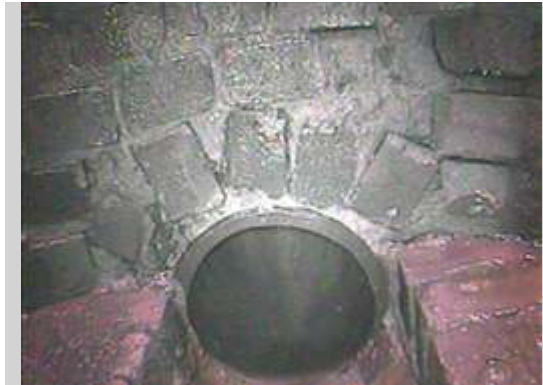
Drop In @ 6 O'Clock

Drop: **Outside** **Direct**

Drop Condition: **Open**

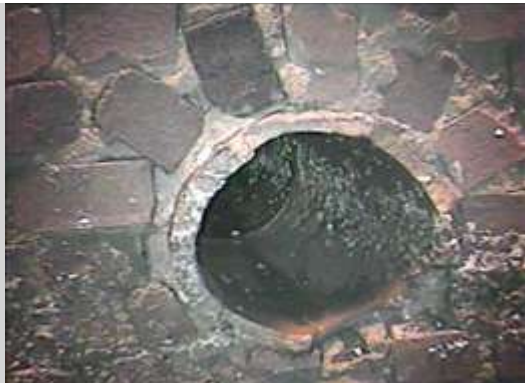
8 O'Clock Inflow

Pipe In @ 8 O'Clock

Infiltration: **None** Pipe Seal Cond: **Sound**

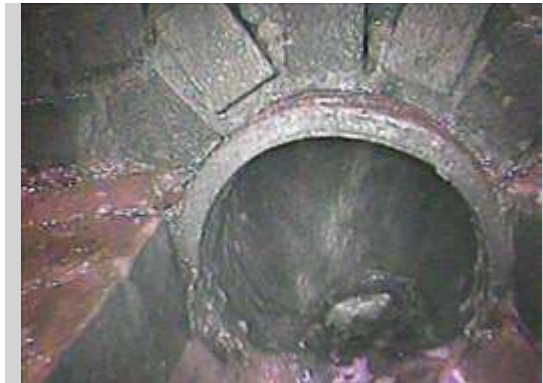
Drop In @ 8 O'Clock

Drop: **Outside** **Direct**

Drop Condition: **Open**
